Techniques and Tools of NASA's Space Shuttle Columbia Accident Investigation

Steve McDanel¹

1. Steve McDanel, Chief, Failure Analysis and Materials Evaluation Branch, National Aeronautics and Space Administration (NASA), Kennedy Space Center, Florida, USA

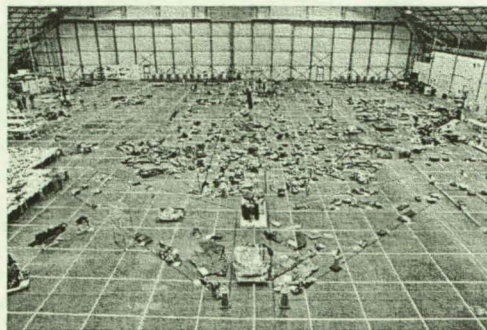
Figure 1. Columbia Reconstruction Hangar. The debris represents approximately 3% of the total debris recovered and includes metallic structures, reinforced carbon-carbon composites, and ceramic heat insulation tiles [1].

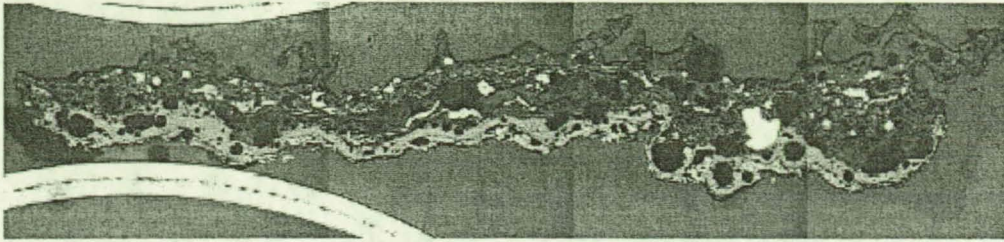
Analytic testing included such techniques as Energy Dispersive Electron Microprobe Analysis (EMPA), Electron Spectroscopy Chemical Analysis (ESCA), and X-Ray dot mapping; these techniques related the characteristics of intermetallics deposited on the leading edge of the left wing adjacent to the location of a suspected plasma breach during re-entry.

Figure 2. Materiallographically-prepared cross-section of a slag deposit from LH Panel 8 [2]. Note higher-z metallic deposits in lighter-z metallic matrix. Magnification: 8X
